Preliminary Science Flight Report

Operation IceBridge Arctic 2011

Flight: D11

Mission: Box 5 Flight 3

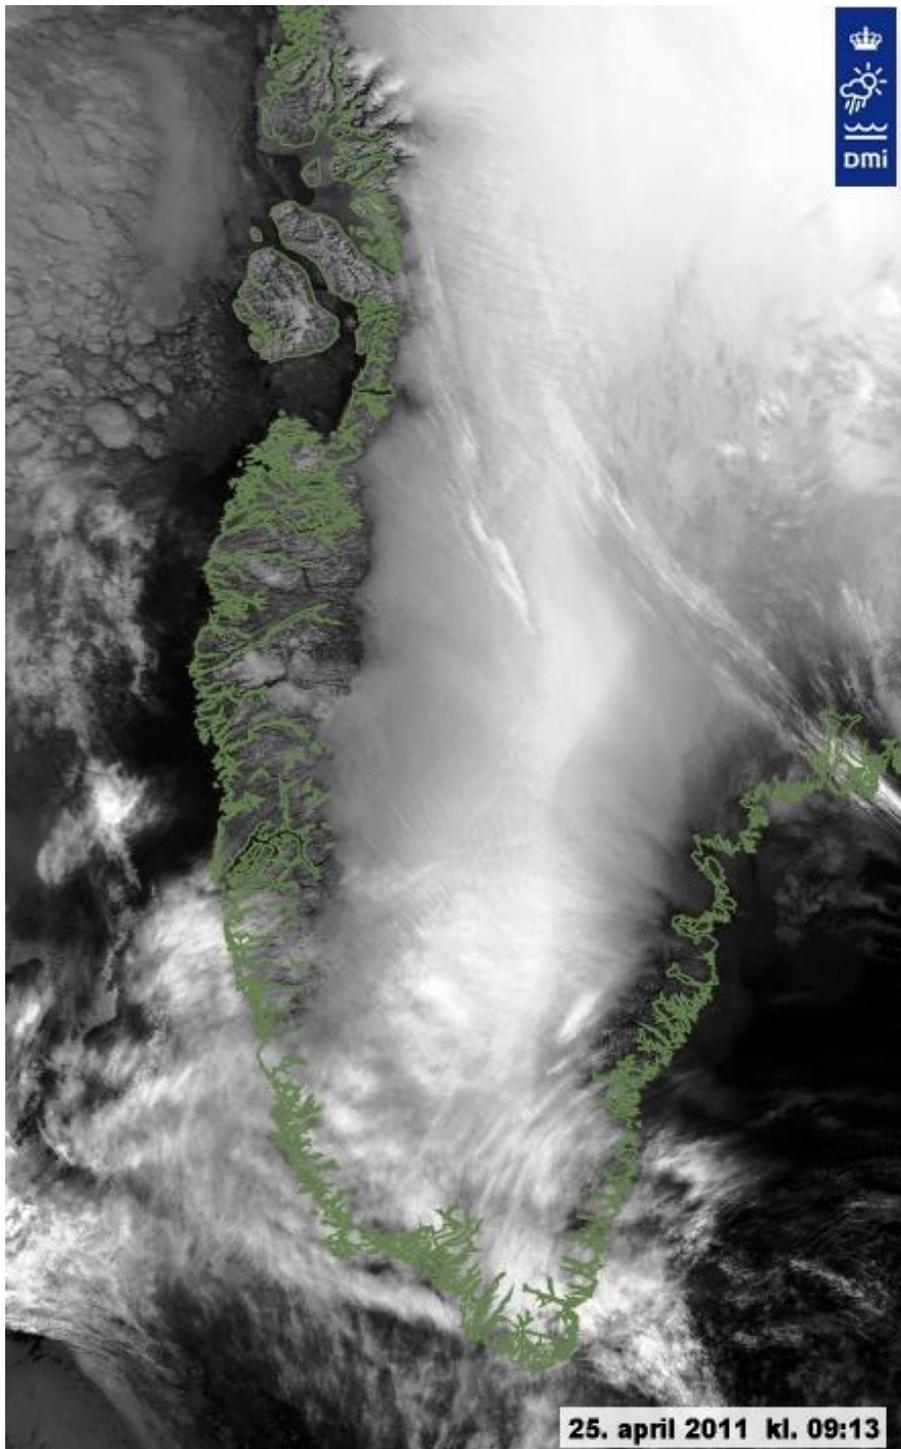
Figure 1: IR Satellite image taken during the flight.

Today's mission was the third mission to be flown in Box 5 which is located north of Kangerlussuaq. The southern end of Box 5 is at Kangerlussuaq and the northern end at the southern end of Disko Bay. As shown in the satellite image (Figure 1) the region had some alto cumulus clouds at take off. The clouds were encountered by the plane in the center portion of Box 5 but they did not affect the surface return from LVIS. Box 5 is one of two highest priority boxes. Today's flight was planned to survey 3 ICESat Track, 3 additional grid lines in the ice sheet interior portion of Box 5 and transit on the Russell/Isunguata glacier line (Figure 2). Only the transit on the Russell/Isunguata glacier line, 1 grid line and 1 ICESat track were actually flown today on today's flight due to a crack aircraft windshield cutting the flight short (Figure 3).

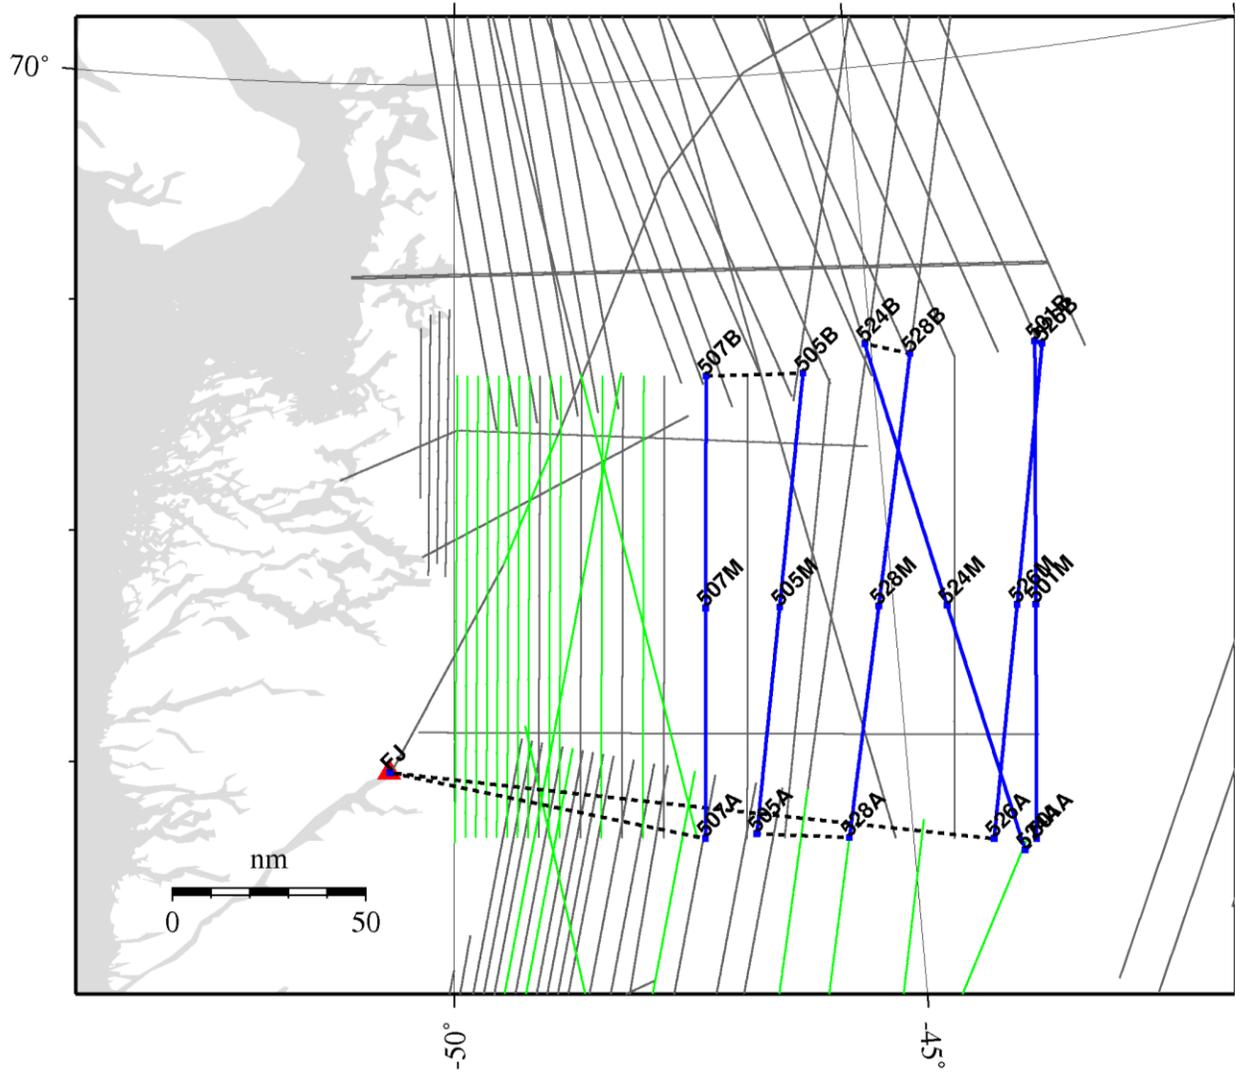
Figure 2: Proposed B200 flight plan for April 25, 2011 (blue). Green lines are previously flown lines. Only the eastern most lines were flown due to a cracked aircraft windshield.

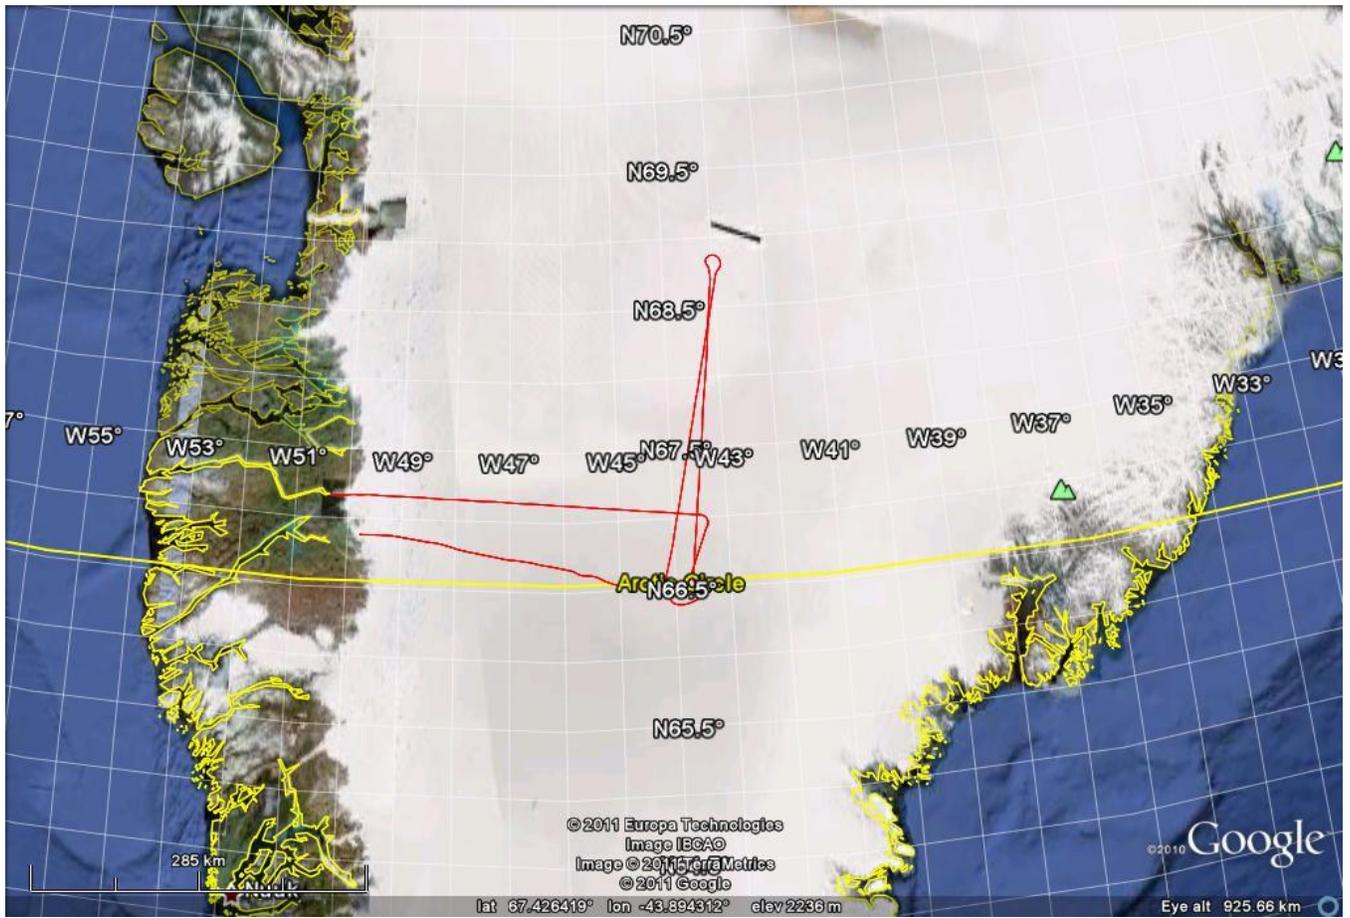
Figure 4: Actual trajectory of today's flight showing the Isunguata Sermia/Russell Glacier line and the two eastern most lines were accomplished before the aircraft windshield cracked and the aircraft returned to Kangerlussuaq.

The B200 took off at 1020 Z from Kangerlussuaq and completed a pitch and roll and a ramp pass at 19000 ft. The plane was held at this altitude by Air Traffic Control as it transited on the Russell/Isunguata glacier line. After about a quarter of this line was completed the plane was cleared to 28,000 feet. The plane transited to the eastern end of Box 5 and then preformed a southward turn to line up on ICESat track 174 which it followed for 131 nmi to the north. The plane headed south on the eastern most grid line in Box 5. As the plane turned to head north again the windshield on the right side of the plane cracked. The science portion of the mission was ended. The plane descended in altitude, reduced speed and returned to Kangerlussuaq landing at 1351. The crack windshield will be replaced as soon as possible.

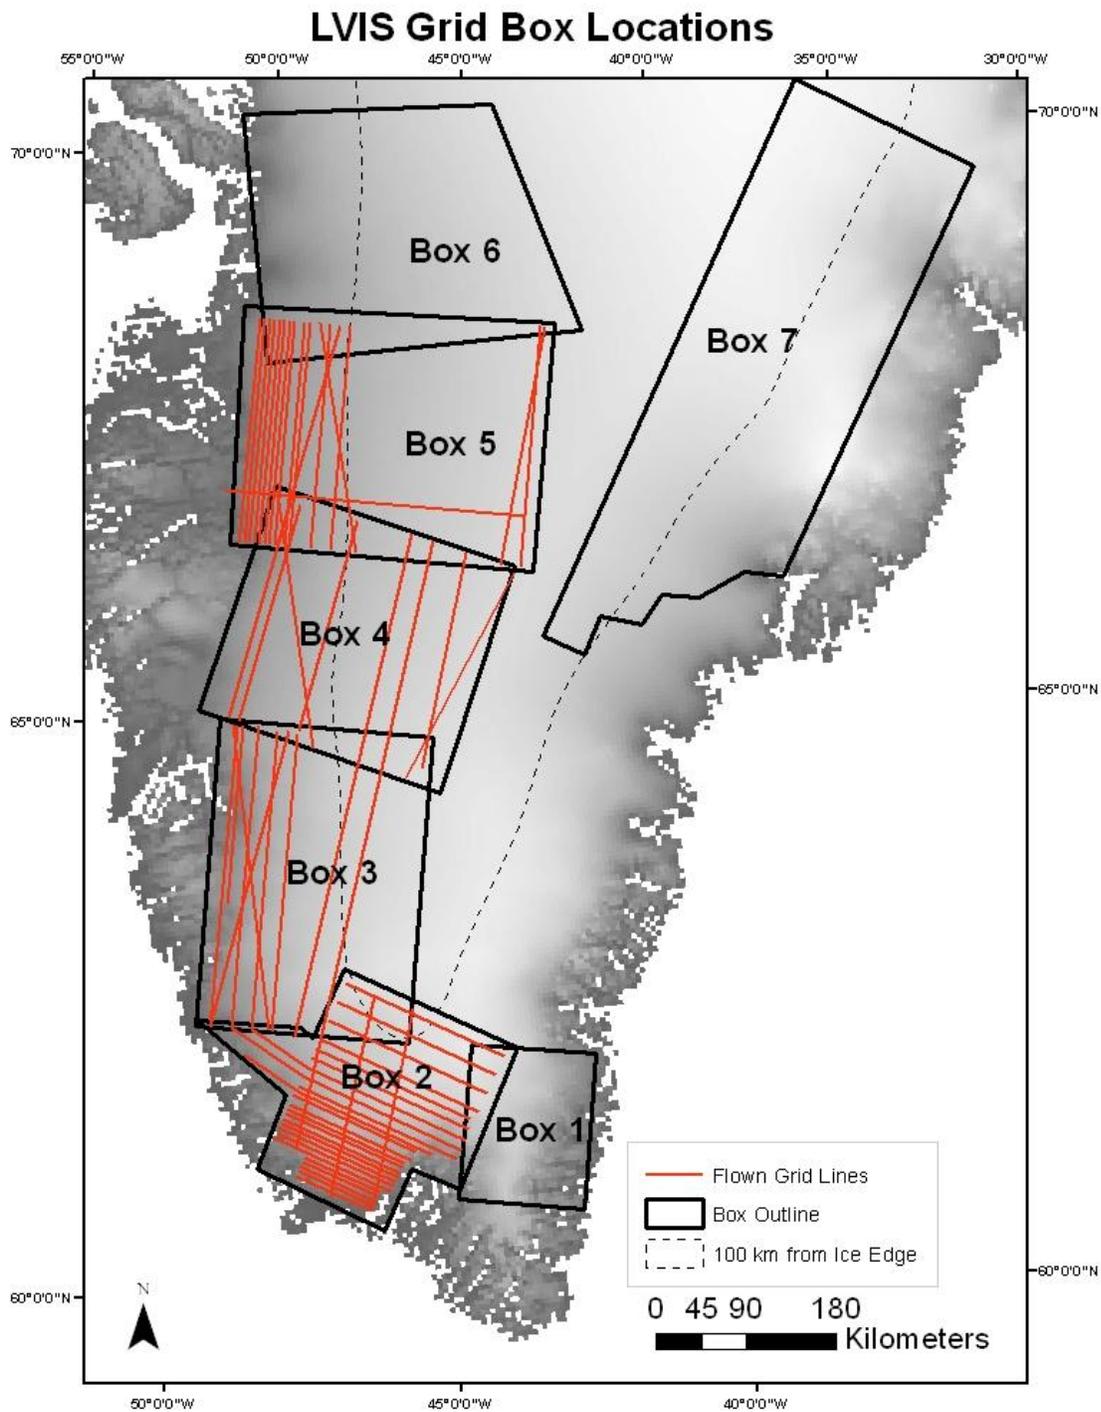
Figure 3: LVIS grid lines flown to date during the B200 Arctic 2011 Operation IceBridge Campaign.

Figure 4 below shows the coverage to date of the LVIS/ B200 grids line from this campaign.
